MARINE INVESTIGATION REPORT

M00C0026

STRUCTURAL FAILURE

BULK CARRIER *ALGOWOOD*

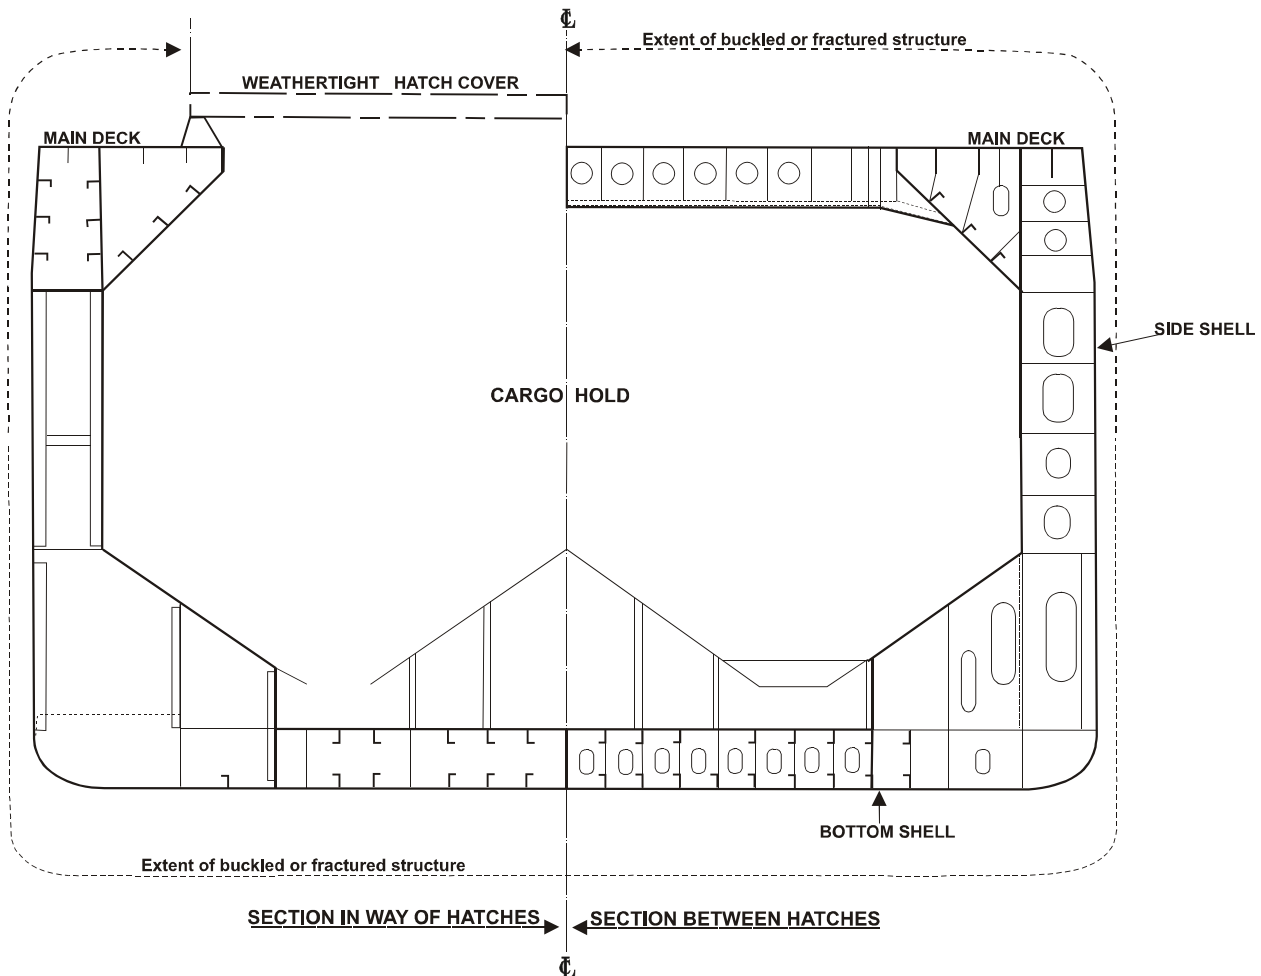
Figure 3. Location and extent of initial hull damage

The *Algowood* experienced a sudden, major structural hull failure, the location, nature, and extent of which are shown in figures 3 and 4 and photographs 1, 2, and 3. Damage surveys, carried out when the vessel was alongside at Bruce Mines, revealed extensive buckling and distortion on the deck (see Figure 4) above waterline P & S shell plating with localised buckling and tensile fracturing of the side shell and of the P & S ballast tank hopper⁶ side.

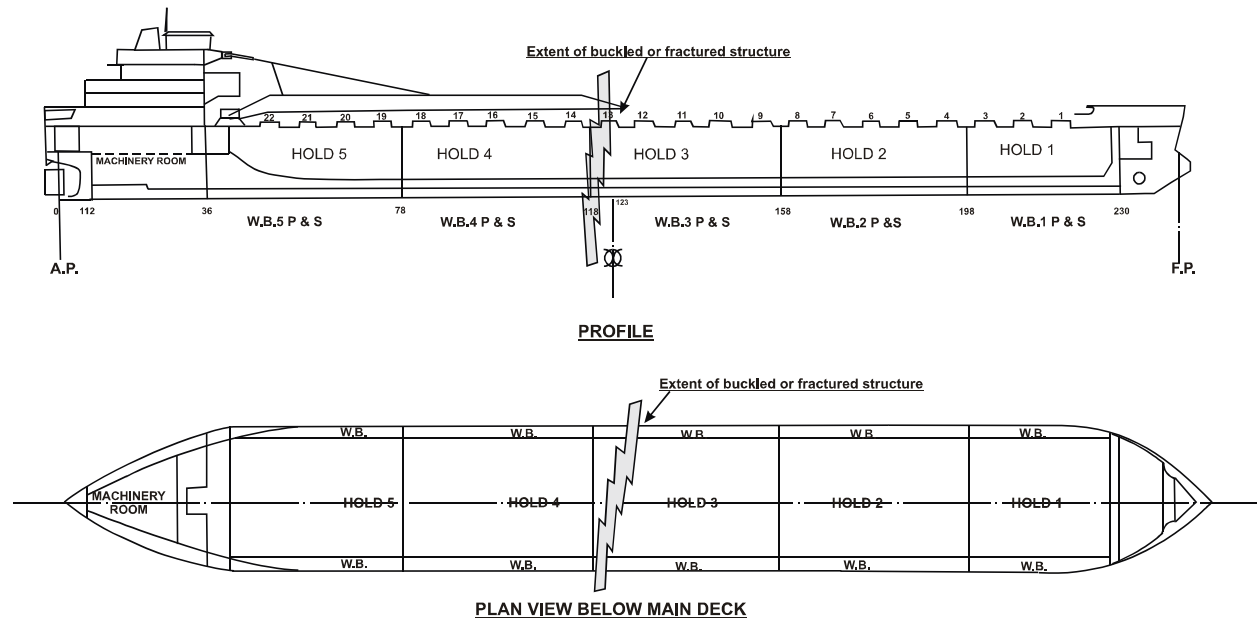
Figure 4. Damage Location

At 2345, while continuing to load into hatch No. 3 of cargo hold No. 1, the ship made a very loud wrenching sound and buckled⁴ between hatches nos. 13 and 14, in way of the transverse bulkhead, between frames 117 and 119. Loading was stopped and the general alarm sounded.

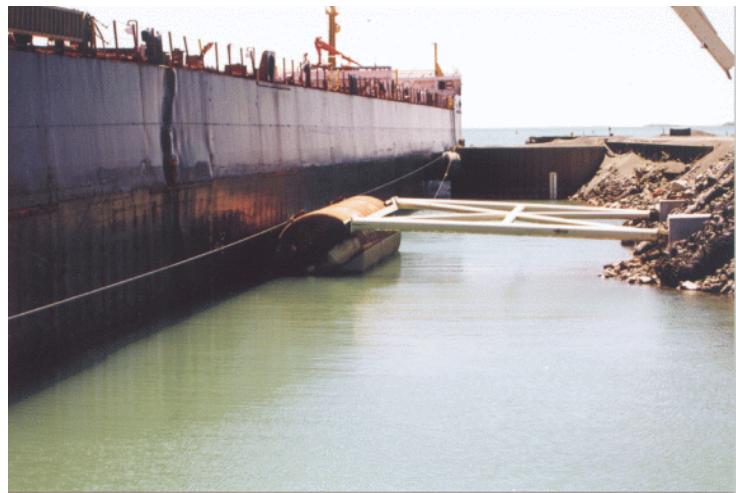
Inspection while in dry dock revealed structural buckling and extensive fracturing from the turn of the bilge⁷ to the bottom shell⁸, P & S, inner bottom, and P & S ballast tank hopper side plating in way of the transverse bulkhead between frames 117 and 119, between holds nos. 3 and 4 (see Photograph 2). The inspection in dry dock also revealed other deformations, distortions, and localised fractures in the forward and after sections of the bottom shell plating. These were caused by the vessel contacting and settling on the bottom during the occurrence.

Photograph 1. Starboard side of damaged vessel showing longitudinal deflection of hull

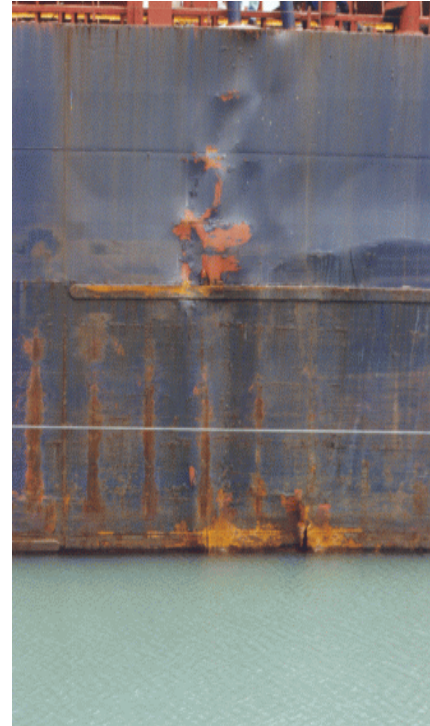
Photograph 2. Buckling and fractures on starboard side

These calculations confirmed that, immediately before hull failure, the vessel was subjected to a hogging/bending moment about 2.3 times the maximum permissible (sea going). A hogging/bending moment puts the main deck plating in tension and the bottom structure in compression. The hogging condition, induced at the time of the occurrence, was due to the excess of weight over buoyant support at the ends of the vessel.

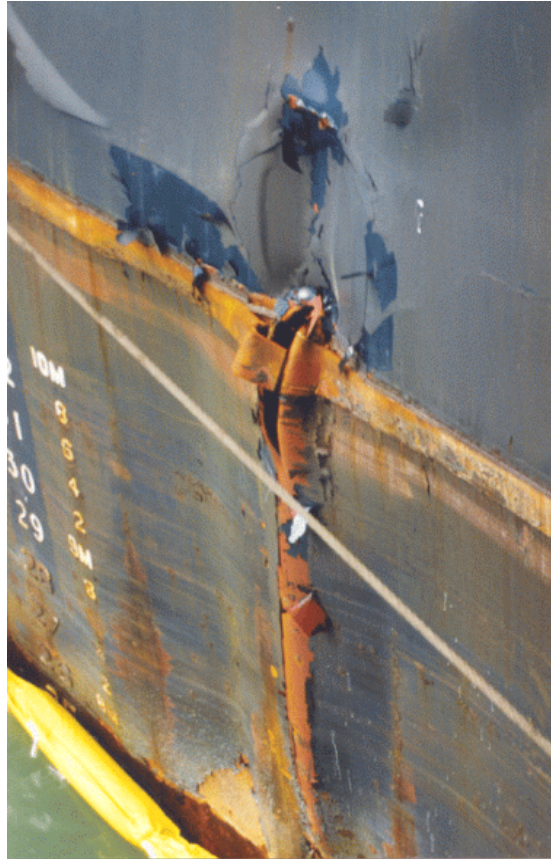
Photograph 3. Buckling and fractures on the port side

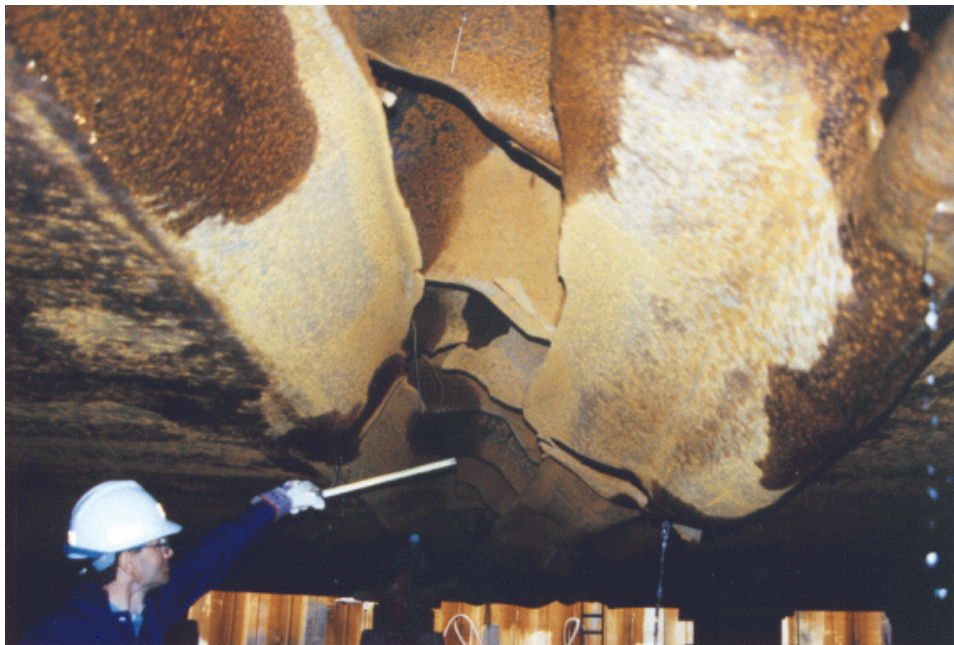
Photograph 4. Fracture damage to bottom plating in way of the transverse bulkhead between frames 117 and 119

Deviations from the loading sequence, combined with a lack of appropriate compensatory ballasting measures to minimize hull stresses, caused the vessel to hog. The mechanical failure of the bottom structure occurred when compressive stress exceeded the critical buckling stress of the bottom structure. This caused extensive buckling and tensile fracturing of the adjacent structure, which culminated in the loss of longitudinal hull integrity.
